**MARYLAND HISTORICAL TRUST
DETERMINATION OF ELIGIBILITY FORM**

Property Name: Michael & Bernadette Wilson Farm Inventory Number: CARR-1710
Address: 3510 Bullfrog Road Historic district: yes ☒ no ☐
City: Taneytown, MD Zip Code: 21787 County: Carroll
USGS Quadrangle(s): Taneytown
Property Owner: Michael and Bernadette Wilson Tax Account ID Number: _____
Tax Map Parcel Number(s): 1 Tax Map Number: 18
Project: MD 140 over Monocacy River Bridge Replacement Agency: FHWA/SHA
Agency Prepared By: MD SHA
Preparer's Name: Anne E. Bruder, Architectural Historian Date Prepared: 04/01/2009
Documentation is presented in: Project Review and Compliance files.
Preparer's Eligibility Recommendation: _____ Eligibility recommended ☒ Eligibility not recommended ☐
Criteria: ☒ A ☐ B ☒ C ☐ D Considerations: ☐ A ☐ B ☐ C ☐ D ☐ E ☐ F ☐ G
Complete if the property is a contributing or non-contributing resource to a NR district/property:
Name of the District/Property: _____
Inventory Number: _____ Eligible: ☐ yes ☐ no ☒ Listed: ☐ yes ☐ no ☒

Maryland Inventory of Historic Properties Form

Inventory No. CARR-1710

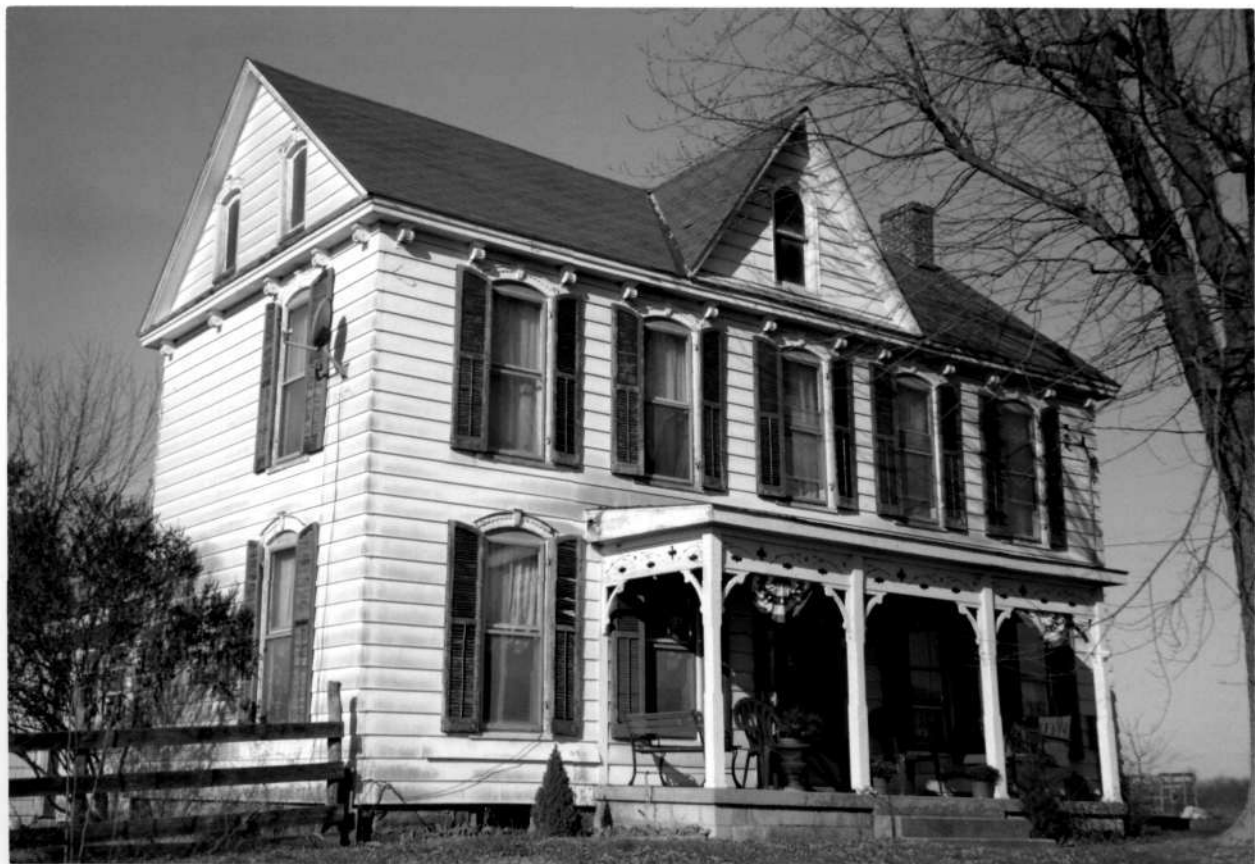
Y/H

The Wilson House is a 2-1/2 storey, five bay, double pile dwelling. It has a side-gable roof with a front gable dormer above the center entrance. There is one rear two story addition on the west façade and an attached summer kitchen southwest of the main pile. These dependencies are integral to the original construction of the main pile. The windows are one over one and are surrounded by decorative exterior frames. The main pile is clad in aluminum, while the rear addition is clad in asbestos shingles. The front porch roof is a shed variety and it is supported by a decorative cornice, brackets and posts, extending along three of the five bays. The deck is made of concrete, which is supported by concrete blocks. Likewise the roof cornice is supported by decorative brackets. A shed-roof hyphen connects the rear addition to the summer kitchen. The rear two storey addition has two bays and a front gable roof. There are two exterior chimneys. The main entrance is surrounded by six lights.

WILSON HOUSE - EXT E, SOUTH
FACADES.

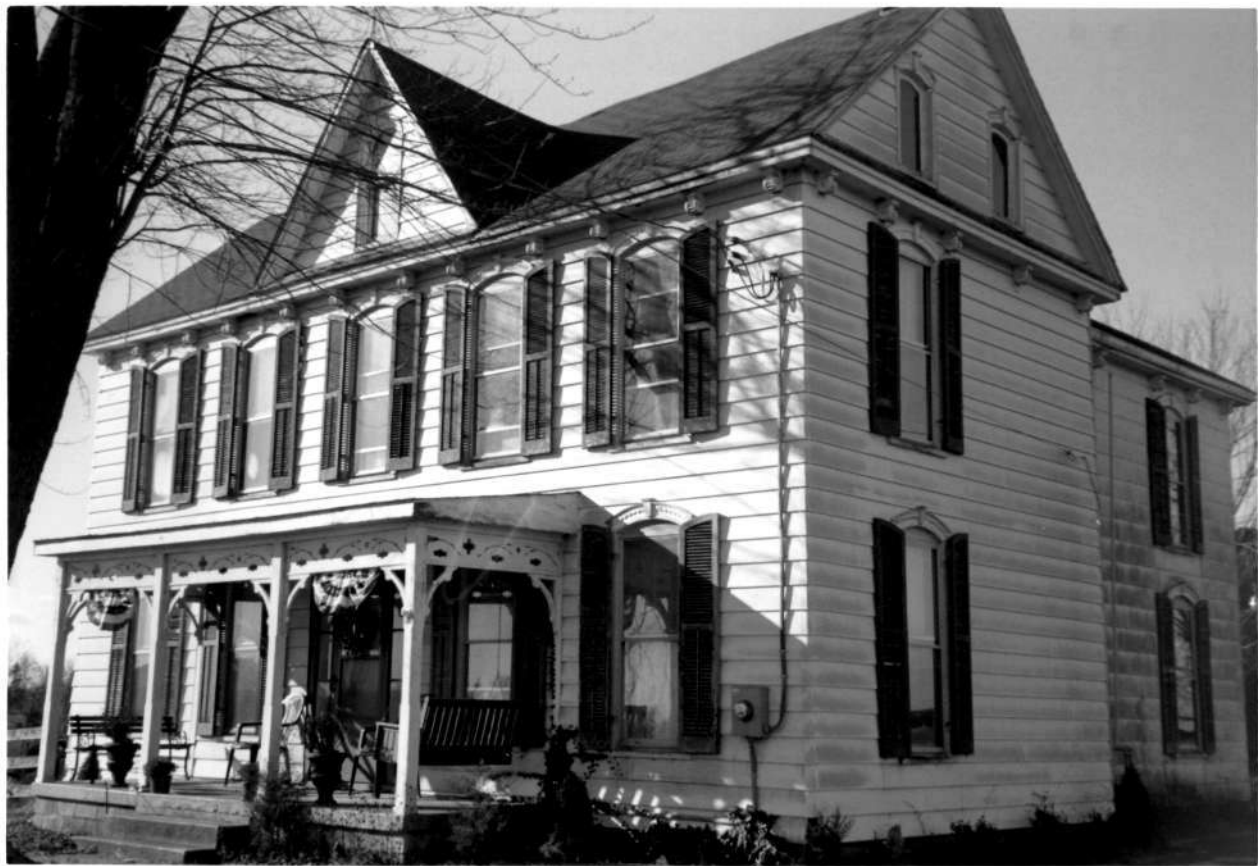
2/11

EAST & NORTH FACADES WILSON
HOUSE

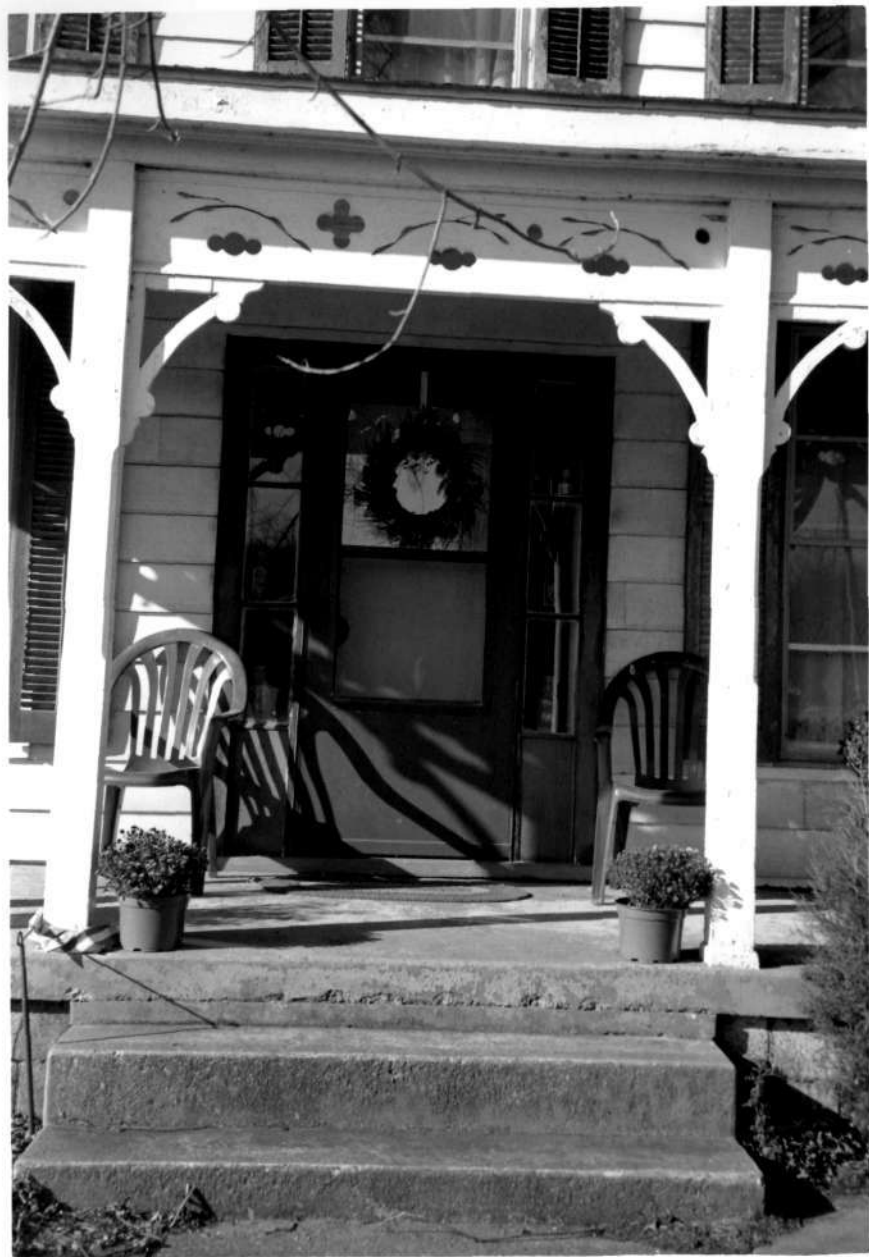
3/11

WILSON HOUSE MAIN ENTRANCE

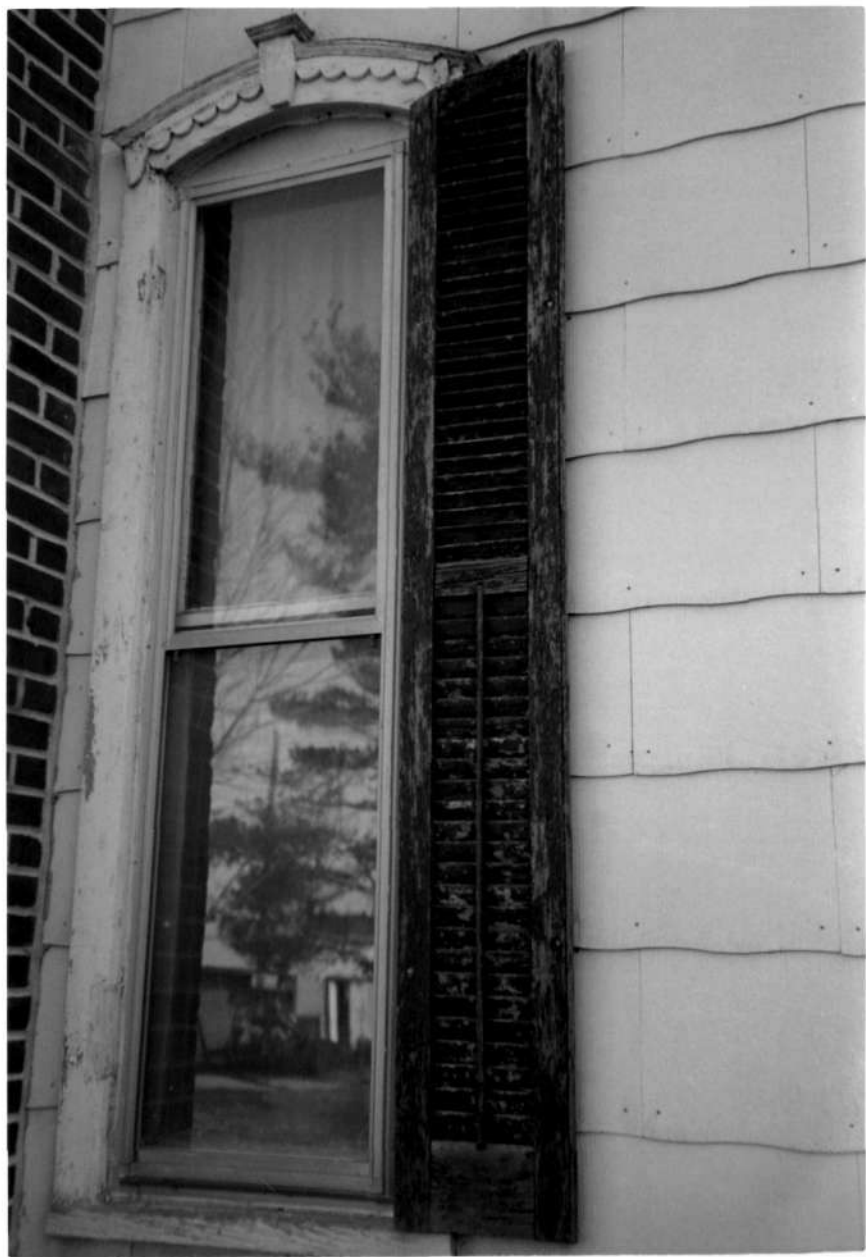
4/11

WILSON HOUSE, WINDOW IN NORTH
FACADE.

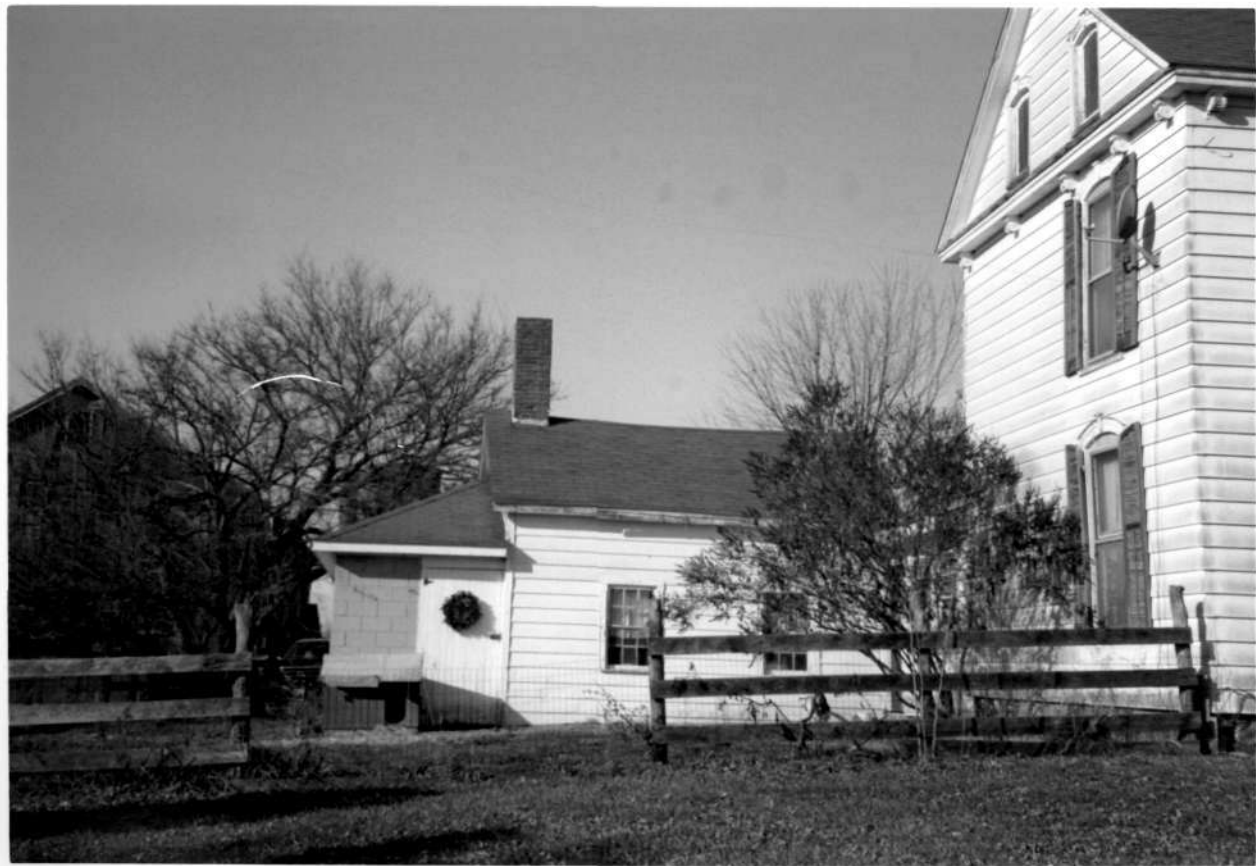
5/11

The summer kitchen has one story and an attic. The roof has log rafters supporting it, but the exterior roof is clad in asphalt shingles. There is a large stone fireplace on the first floor. It has one hipped roof, concrete block addition on the south façade. The windows are six over six, and the exterior is clad with aluminum siding.

WILSON FARM SUMMER KITCHEN
(EAST FACADE).

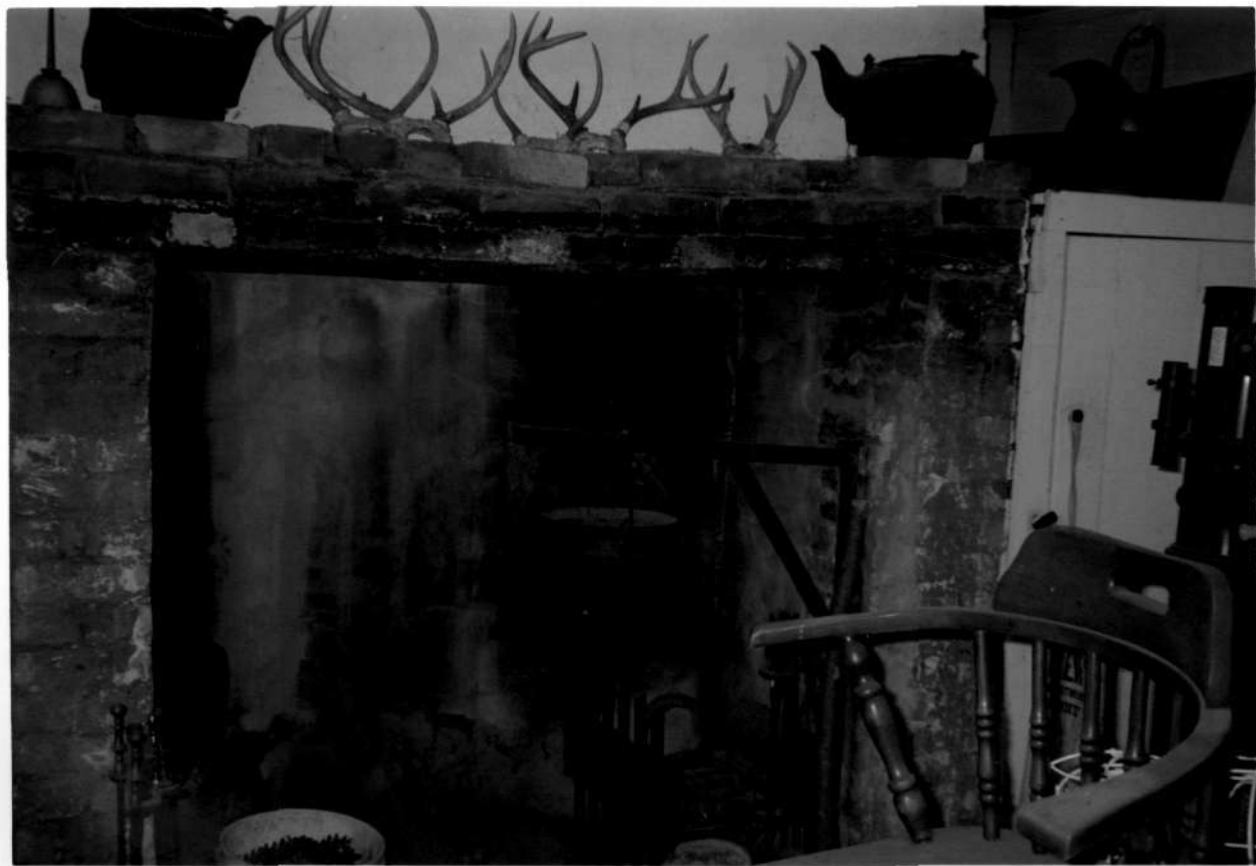
6/11

INTERIOR OF SUMMER KITCHEN -
FIRE PLACE.

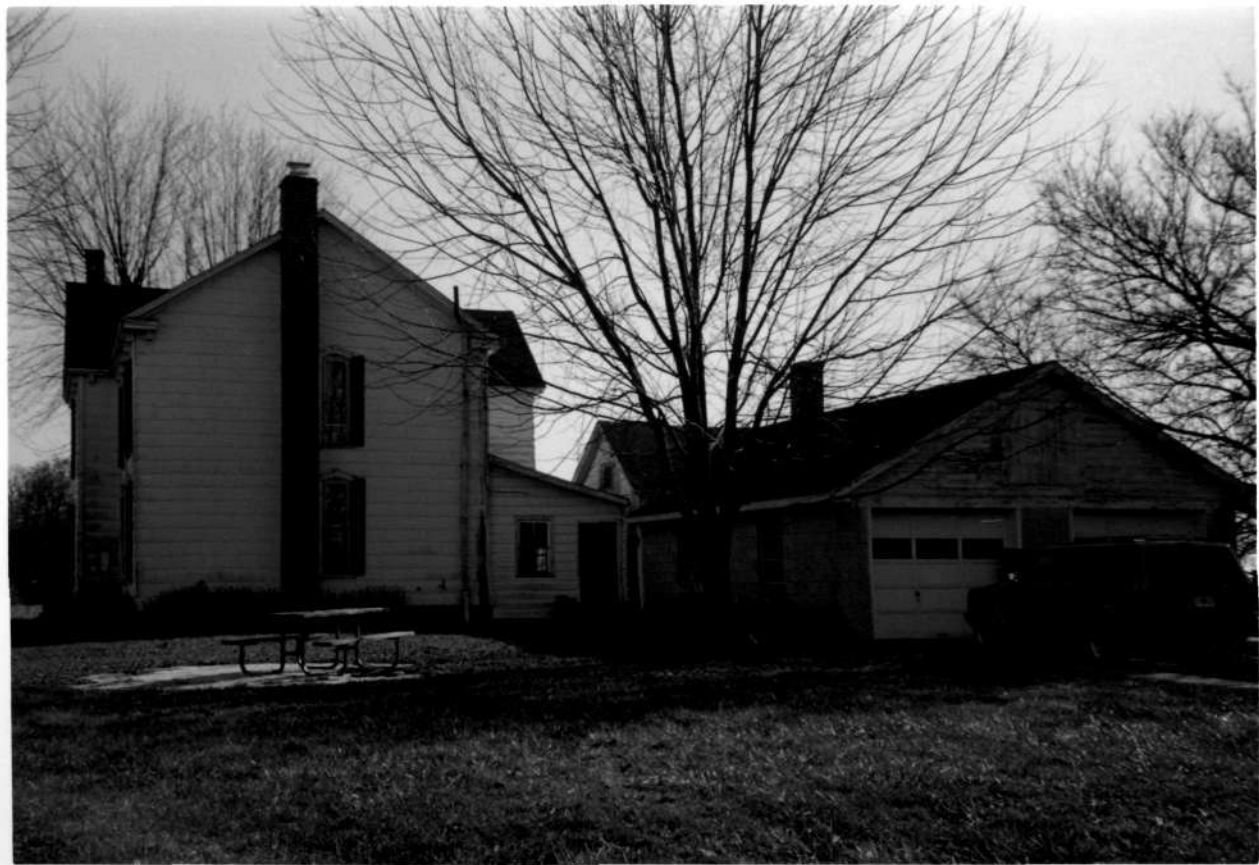
LOOKING AT WEST (SIDE) OF HOUSE
7/11

The Michael and Bernadette Wilson Farm is a 143.9 Acre farmstead on the southeast side of MD 140 and the Monocacy River in Carroll County, Maryland. It consists of 7 buildings – a house, an attached summer kitchen, a bank barn, a concrete silo, a shed and a chicken coop. The two-car garage is attached to the summer kitchen and is not fifty years of age.

WILSON HOUSE, BEING TO CHED,
SUMMER KITCHEN & GARAGE

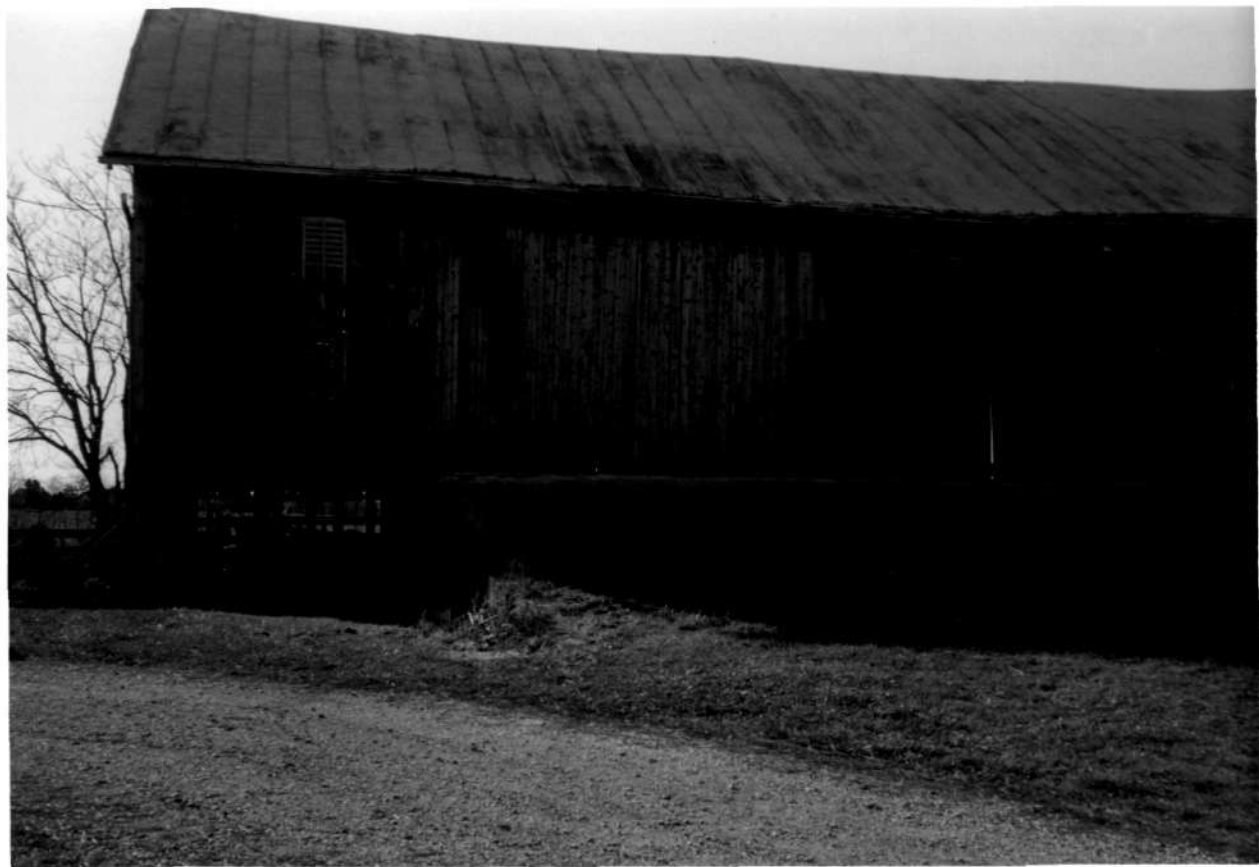
2/11

Bank Barn and concrete silo – the barn is an example of a German bank barn with vertical siding, a standing seam metal roof and louvered vents. The double doors are in the center of the north wall. The eastern end of the barn extends out from the bank allowing passage to the pasture on the south side of the barn. The concrete silo appears to be an example of a concrete stave silo, although the horizontal staves and roof are missing. The bank barn and silo are not currently in use.

The outbuildings represent a continuous farming history from the late nineteenth through the mid-twentieth centuries. The outbuildings were used for dairying, as well as for raising chickens, and maintaining winter feed in the silo. The bank barn dates to the late nineteenth century, has a timber frame, but is not currently in use by the present owner.¹

RARE FARM LOOKING AT NORTH

FACADE

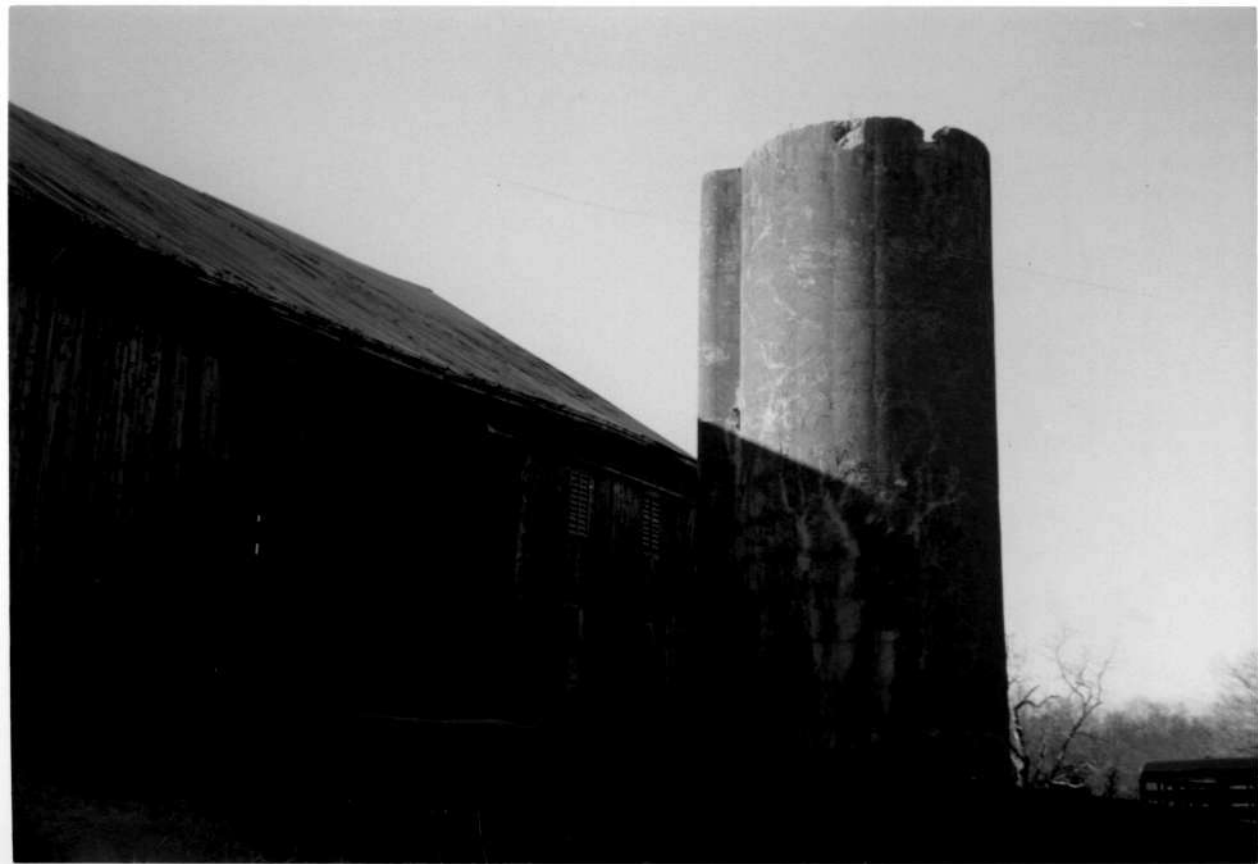
9/11

The concrete silo dates to the 1920s or 1930s. The concrete stave silo was introduced in 1910, and it appears that the exterior metal bands have been lost, as has the roof. According to the present owner, Michael Wilson, earlier owners built a trench silo further to the west, beyond the barn. Trench silos were more common when keeping silage first became popular in the third quarter of the nineteenth century.² Like the bank barn, it is no longer used.

CONCRETE SILO @ FANK FARM.

LOOKING SOUTHWEST

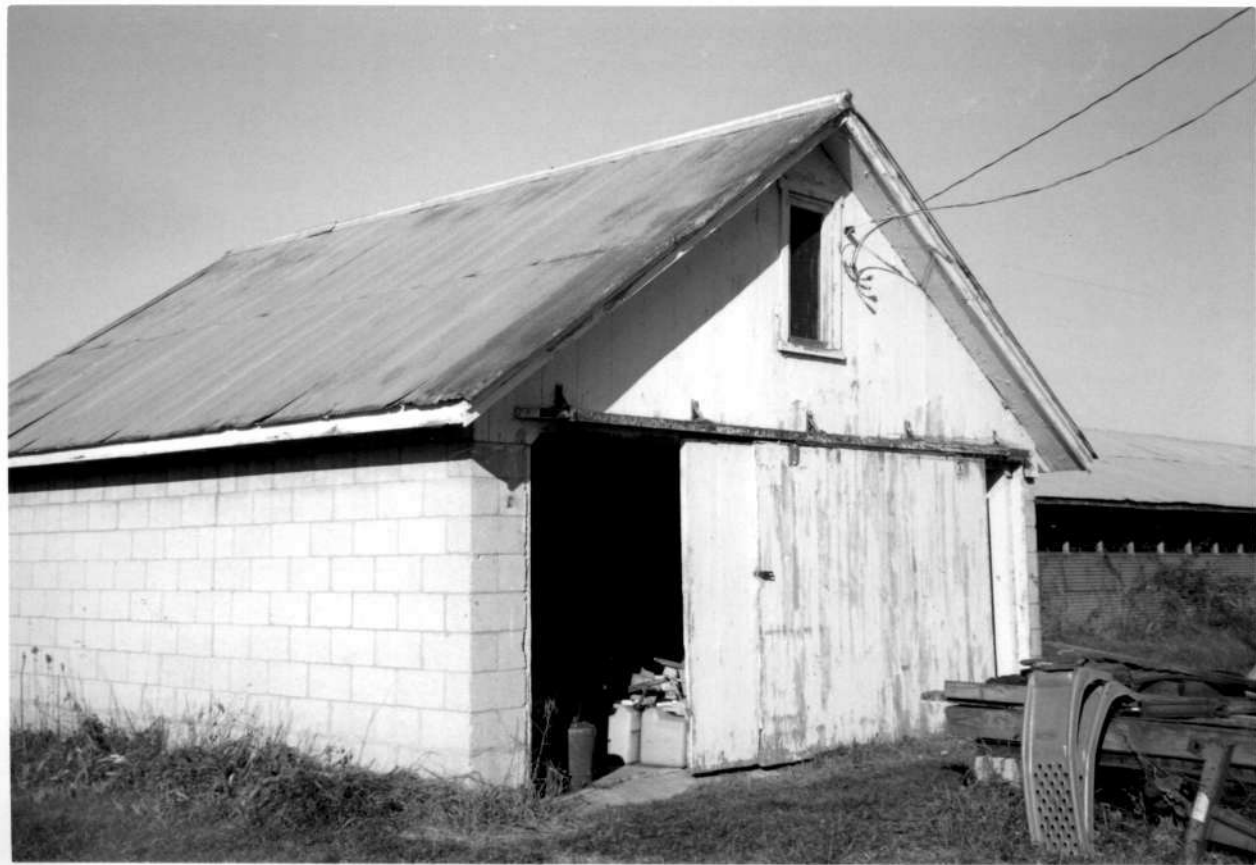
10/11

Corrugated metal tractor shed – a large, metal building with a gable roof, used at one time as a chicken house.

WILSON FARM. SAKED #1

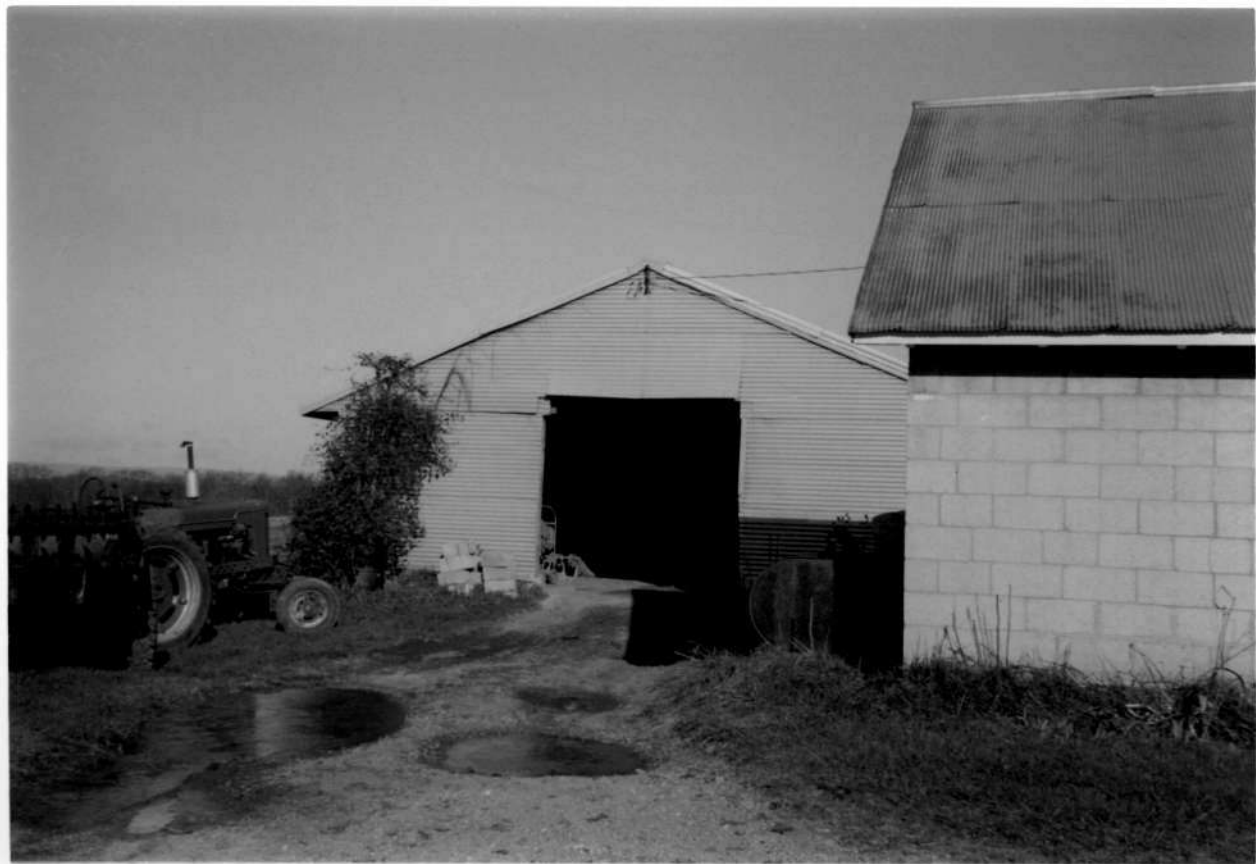
Concrete block building with front gable corrugated metal roof has a double sliding door and one window in the front gable.

Wilson Farm Sided #2
